## TECH NOTE

# AUTOMOTIVE – PASSENGER CAR INCORRECT ROTATION CAN LEAD TO SYSTEM FAILURE ON HOLDEN 1.6, 1.8, 2.0, 2.2 16V ENGINES

BULLETIN: TSB001\_AU

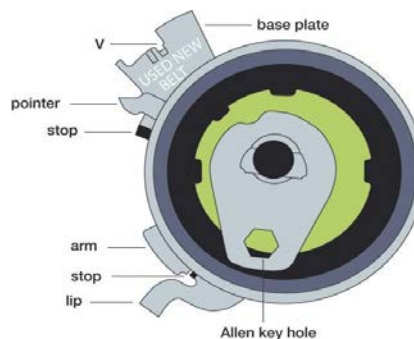
Fig. 1

2. Block camshafts
  3. Loosen tensioner bolt
  4. Turn tensioner clockwise and remove belt
  5. Remove old tensioner
  6. Install new tensioner, hand tighten bolt. Tensioner lip has to be in oil pump housing slot. (Tensioner pointer has to sit behind water pump pulley). The allen key hole has to be set in +/- 7 O'clock position (Fig. 1).

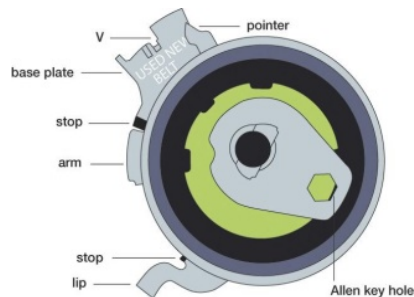
Fig. 2

8. Turn tensioner (with allen key) anti-clockwise (while holding the bolt in place) till pointer is in line with (not passing) right hand side of base plate. (Fig. 2)

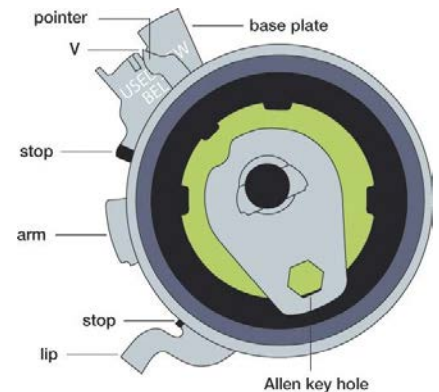
Fig. 3

12. If pointer not in line with V ("NEW" position), block camshafts again.
13. Loosen tensioner bolt
14. Adjust tensioner (while holding the tensioner bolt in place), till pointer in line with V ("NEW" position); the allen key hole has to be in +/- 5 O'clock position now. (Fig. 3)

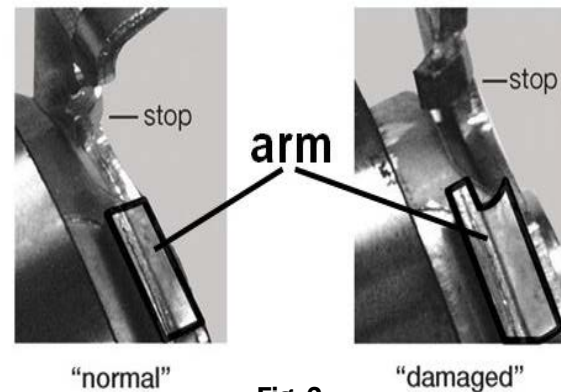
Fig. 2

Rotating the tensioner in the wrong direction, having the allen keyhole in the wrong position to start off, not turning the engine 2 revolutions before and after setting the tension, can lead to system failure. This will cause the arm of the tensioner to hit the stop, creating a hammering noise, damaging and possibly even rupturing that part. This failure mode is very common and can easily be recognised when inspecting the edge of the arm (Fig. 4). The resulting wrong tension can cause the belt to rupture.
