## TECH NOTE

BULLETIN: TSB002\_AU

# CORRECT TIMING BELT CLEARANCE IS CRITICAL ON 2.0/2.5L MANUAL APPLICATIONS

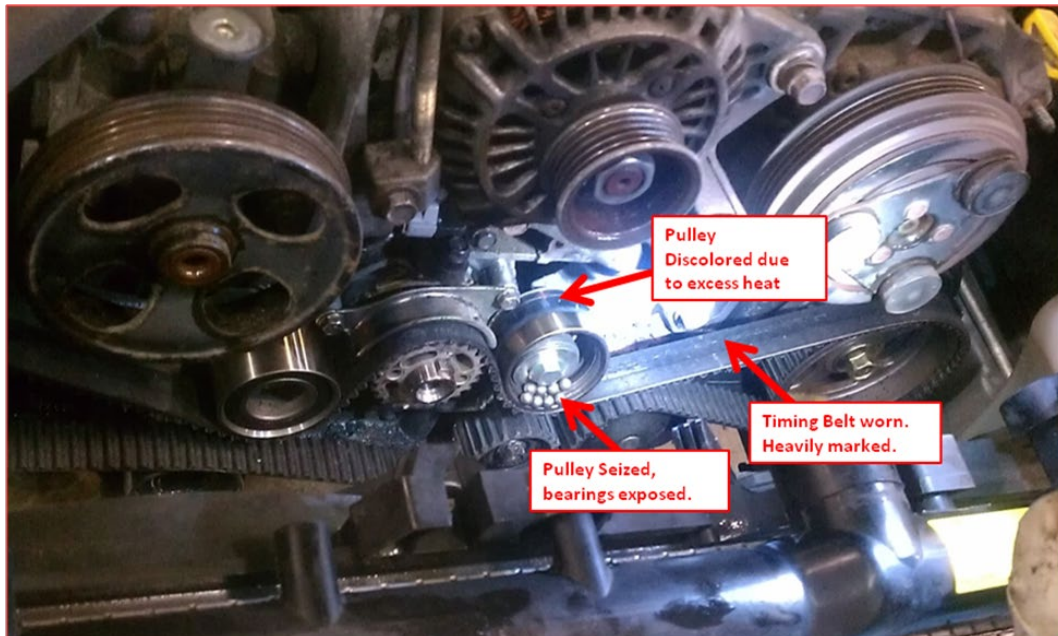
**Fig. 1**

There is a growing number of timing belt and component failures on popular engines. More specifically, the nature of the failure indicates an exposure of the tensioner unit and idlers to extreme heat. In some cases, the heat is so severe that it has melted the top cover of the timing belt. This extreme heat results in the failure of the automatic tensioner, influences the timing belt to 'jump teeth', and ultimately causes serious engine damage. Gates Australia has seen cases where the heat generated has been so severe that the bearings have disintegrated with the vehicle having travelled less than 50 kilometres.

The diagram below (Fig. 1) shows a typical result of the excessive heat generated from this issue:

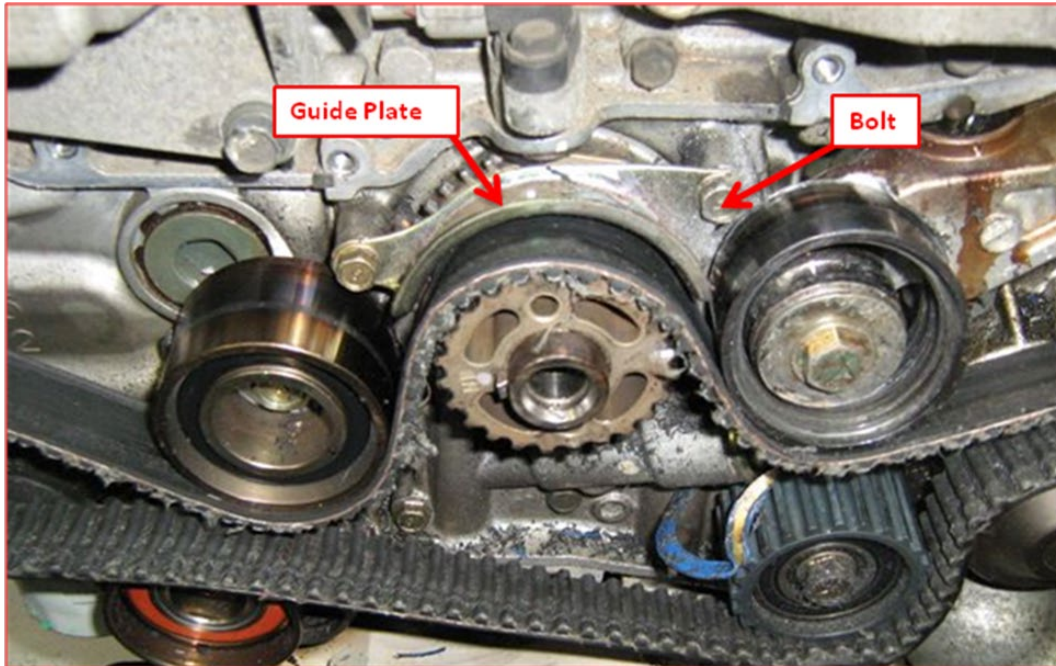
**Fig. 2**

Having said this, upon installation, the rotation of the bolts which secure the guide plate to the engine naturally forces the guide plate down towards the belt (see Fig. 2 below). If the guide plate is installed too close to the belt or if the bolts on the guide plate aren't tightened correctly, the plate can make contact with the timing belt cover. Any contact between the guide plate and belt, and/or an incorrect clearance between the timing belt and guide plate, will cause friction and generate excessive heat. This extreme heat will compromise the bearing's lubricant and lead to bearing seizure/failure.

- Upon installation, the guide plate must have a clearance of 1mm +/- 0.5mm to the belt.
- Having said this, the mounting holes on the guide plate are larger than the bolt which fastens it, and this effectively makes the plate position adjustable. As the bolts are tightened to secure the plate, the rotation of the bolt naturally pushes the plate down towards the belt.

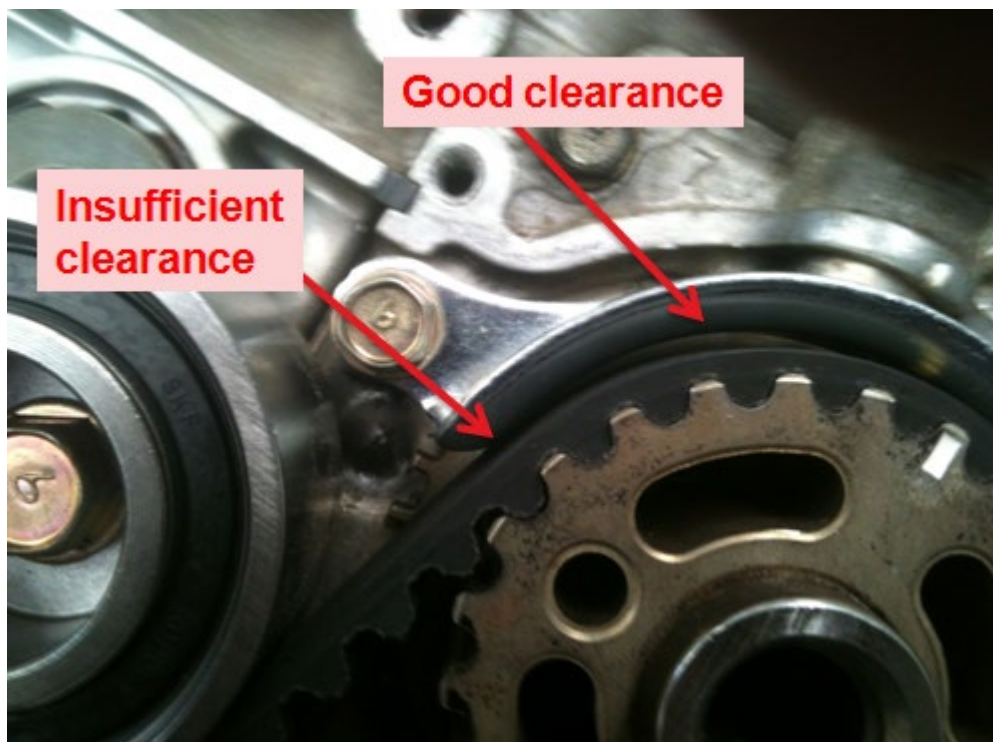
Fig. 3

- This is why the failure mode is becoming more prevalent.
- Also, clearance distance needs to be consistent across the full arc of the plate.
- As such, while there may be adequate clearance in one section of the guide plate, a fitter MUST ensure that the same applies to the other section. As pictured, the top of the guide has clearance however the left side doesn't (Fig 3.).

Unless special care is taken to ensure that the correct clearance is achieved between the timing belt and guide plate, this failure mode will occur. In addition to this, the correct clearance needs to be achieved consistently across the FULL arc of the guide plate.
