## TECH NOTE

# HONDA ACCORD/LEGEND/MDX TIMING COVER MODIFICATION REQUIRED WITH REPLACEMENT OF BELT TENSIONER

**BULLETIN:** TSB005\_AU

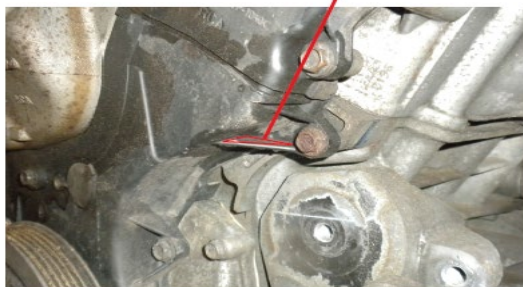
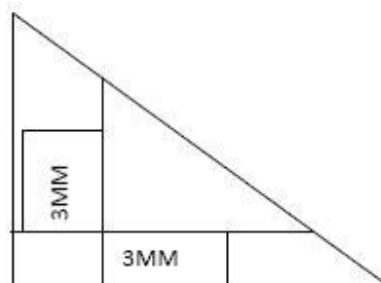
Improper clearance may result in a damaged front timing belt cover.

THIS AREA WILL NEED TO HAVE 3MM OF MATERIAL REMOVED

IMPROPER INSTALLATION MAY RESULT IN A DAMAGED FRONT TIMING BELT COVER AND IMPROPER ACCESSORY BELT TRACKING, EVENTUALLY LEADING TO BELT FAILURE!

The removal of approximately 3mm of plastic material from the lower timing belt cover is recommended prior to the installation of the updated accessory belt drive tensioner, allowing for proper clearance.
