## TECH NOTE

## RECOMMENDATIONS FOR TIMING BELT SYSTEM ON HONDA 1.7L ENGINES

**BULLETIN:** TSB008\_AU

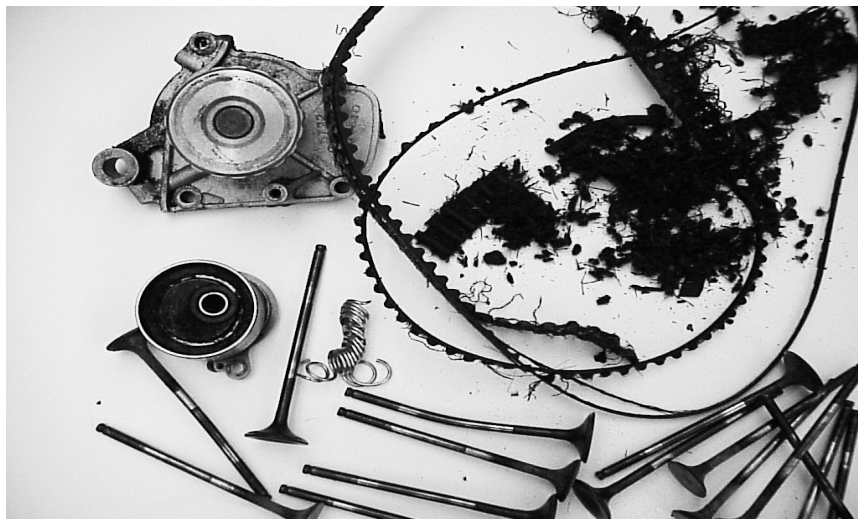
Below is the result from improper belt setup. Notice the damaged spring, this is the result of turning the crankshaft clockwise during initial setup, which is incorrect.

- Incorrect tensioner position
- Improper belt tension

- A violent correction of the tensioner position
- Damage to tensioner and/or spring and/or belt
- Improper belt tracking causing interference with other components
- Catastrophic engine damage due to timing belt and other component failure

Crankshaft must be rotated two turns **COUNTERCLOCKWISE** with locking pin in tensioner and attachment bolt loose. Not following proper installation procedures will cause:

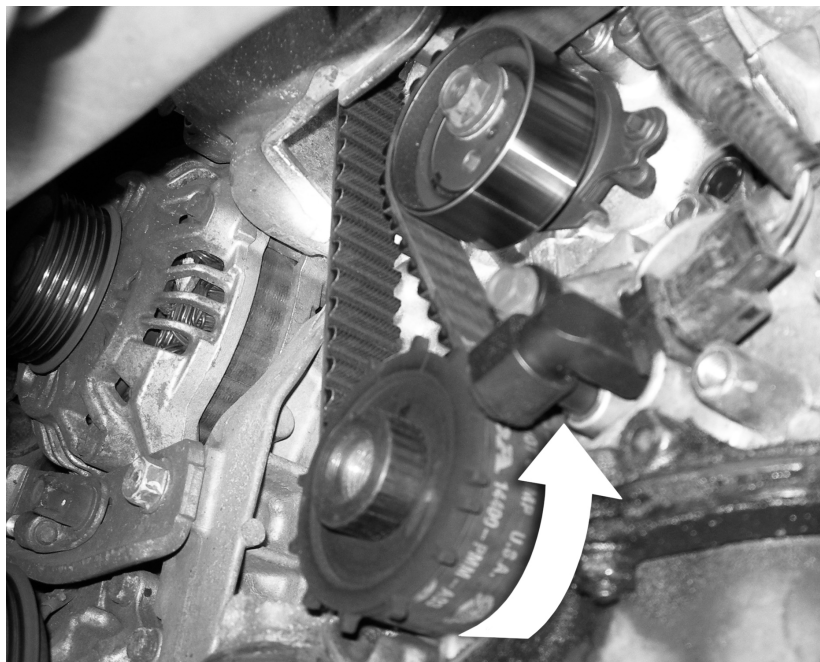
During setup attention needs to be given to the relationship of tensioner spring. The spring must be in the “UP” position which is noted on the spring rubber dampener.

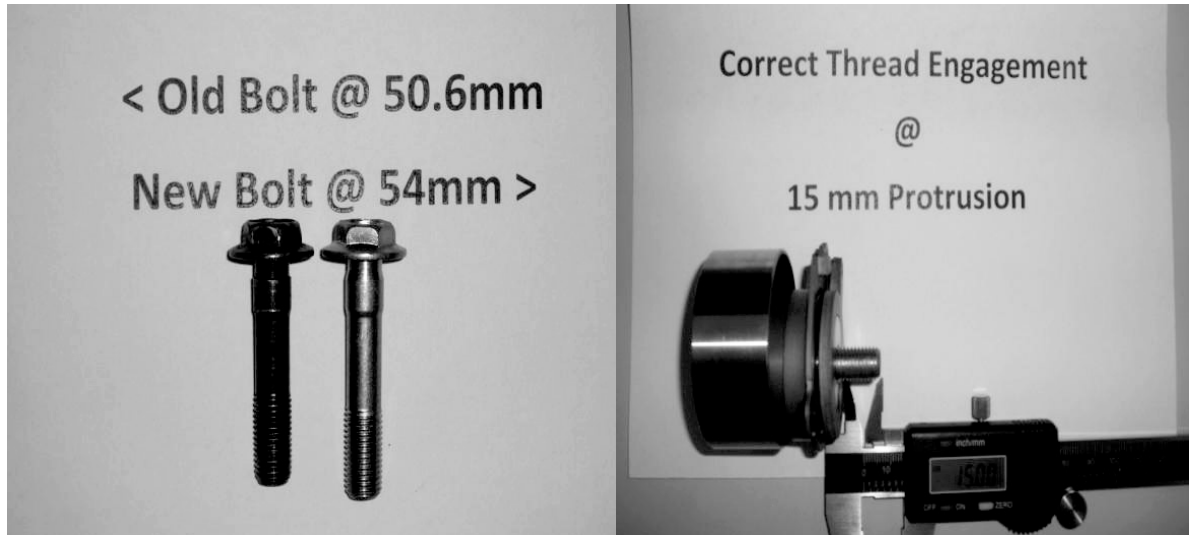
Please be advised that early model year Civics may require an updated tensioner bolt. Honda upgraded the timing belt tensioner assembly in late 2002. Gates Tensioner follows the design change. During this change the OE bolt length was also changed to allow for proper thread engagement. Gates supplies the updated bolt as part of TCK312 Kits.

(Incorrect Bolt Length Is 50.6mm).

Verify this issue with one of the following procedures, the updated OE tensioner and bolt has been provided in this kit.

1. With tensioner fastening bolt placed through tensioner assembly – Verify there is 15mm of thread engagement.
2. Measure Bolt: Bolt length for new tensioner design provided in this kit should be 54mm in length.
