## TECH NOTE

# AUTOMOTIVE –SYNCHRONOUS BELT DRIVE SYSTEM

## TIMING SYSTEM FAILURE DUE TO IMPROPER SERVICING

**BULLETIN:** TSB014\_AU

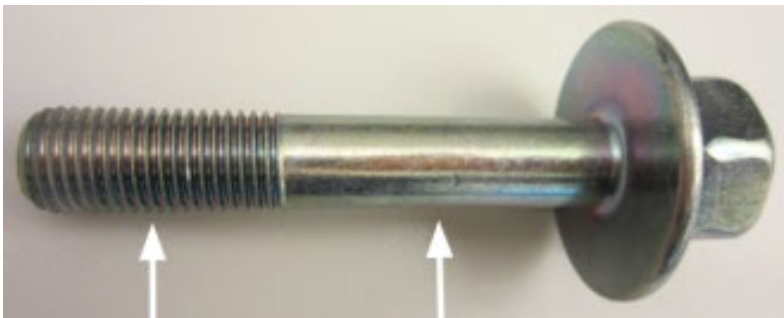
### Crankshaft Pulley Bolt

First, carefully inspect the crankshaft pulley bolt shank and threads for any indication of stretching or “necking”. The bolt’s profile should be unchanged along the entire length of the bolt.

**Inspect the crankshaft pulley bolt and threads for ANY Indication of Stretching!**

The crankshaft pulley bolt on these applications is a Torque to Yield Bolt which means that it is torqued in two stages. The first stage requires the technician to torque the bolt to a nominal newton meter specification. This torque spec identifies the bolt’s elastic deformation point, or the point at which the shape or length of the bolt has not been changed. The second stage requires the technician to observe the degree of rotation the bolt turns while torqueing to an increased newton meter specification. If the bolt does not turn the required number of degrees prior to the torque spec being reached, then the bolt has entered a state of plastic deformation. Plastic deformation is the permanent change of the bolt’s shape or length which requires that the bolt be replaced as it cannot be reused.

Oil the threads and face of the crankshaft pulley bolt and torque to 44Nm. Then torque bolt to 127Nm. lbs. checking that the bolt turns 45°-60°, if not, remove and fit new bolt.

Oil the threads and face of the crankshaft pulley bolt and torque to 44Nm. Then torque bolt to 180Nm. checking that the bolt turns 65°-75°, if not, remove and fit new bolt.
