## TECH NOTE

BULLETIN: TSB\_027\_AU

# FOLLOWING THE OEM INSTALLATION PROCEDURE CORRECTLY IS CRITICAL ON 4D56 DOHC ENGINES

- 2.5L Diesel (4D56 DOHC)

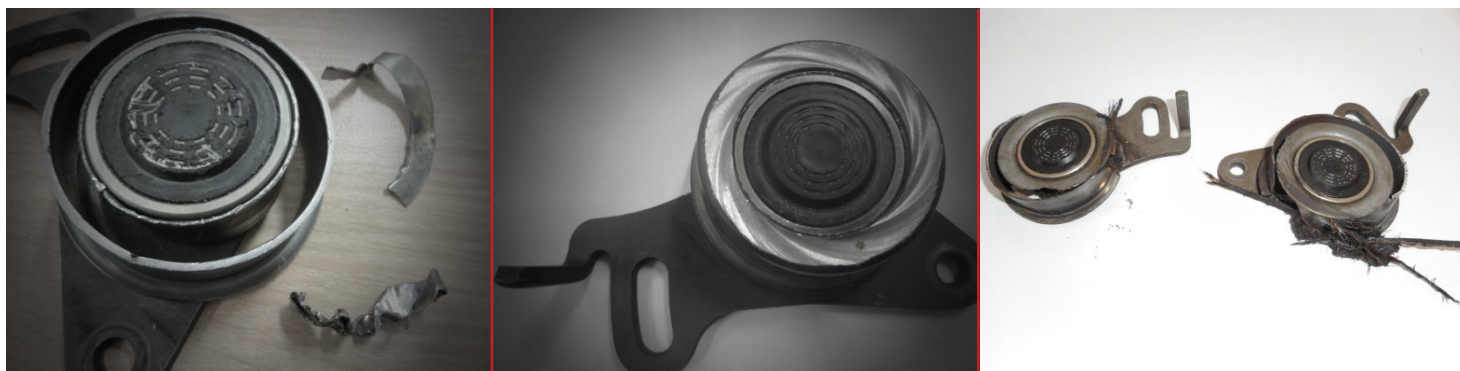
- Camshaft assembly bolt braking.
- Balance shaft tensioner failure.
- Timing belt jumping teeth.
- Balance shaft belt shredding and interfering with the camshaft belt.

Images of failed balance shaft tensioner pulleys due to incorrect installation:
