## TECH NOTE

# AUTOMOTIVE – COOLING SYSTEM

## AUTOMOTIVE SEALANT USE DURING WATER PUMP REPLACEMENT

**BULLETIN:** TSB016\_AU

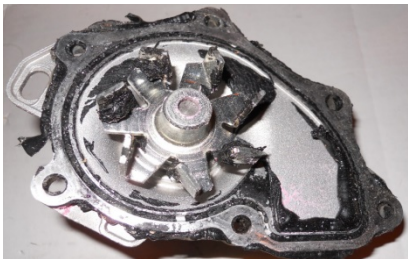
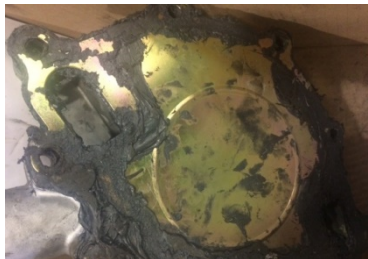
Both pumps were supplied with a cellulose / rubber binder gasket. These gaskets do not require the use of any sealants. However if the mating surface is damaged a small skim coat of sealant is allowable with these types of gaskets.

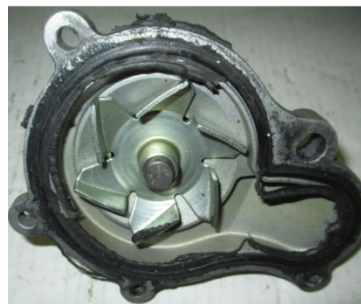
Both pumps were supplied with a rubber / O-ring style gasket. These types of gaskets do not require the use of any sealants.

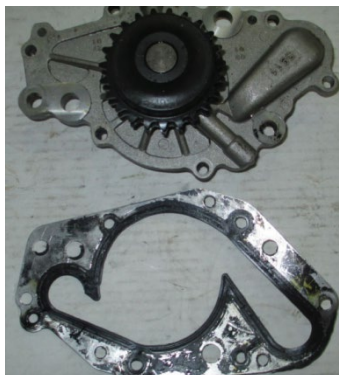
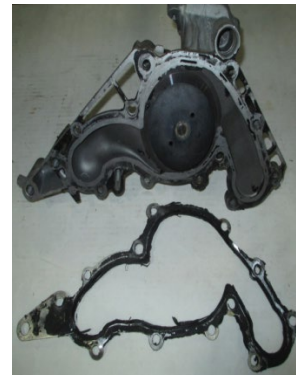
Both pumps to the right were supplied with a metal gasket with a rubber lining the interior perimeter. This type of gasket does not require any sealer. It is clear that over use and misuse of sealants occurred. Installation practices of this nature will lead to premature water pump failures. Premature failures lead to product reliability / quality concerns from customers when in actuality the failure arose from miss-installation / improper use of sealants.

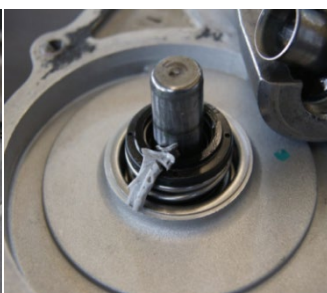
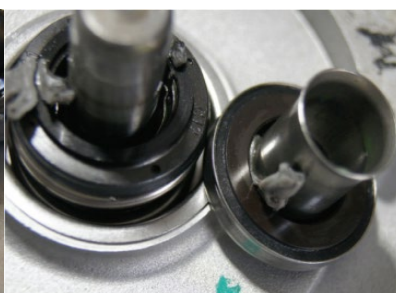
In the examples below one can see where sealer material has been found within the cartridge seal and has led to premature leakage of the water pump and the customer returned the pumps as an alleged manufacturer defect.

To the right are examples of Dynamic and Static seal contamination/ filming /caused by over use of sealants. When sealant particulates / residue get trapped between the Dynamic and Static seal faces it causes a separation of the two surfaces which leads to a seal leak.
