## TECH NOTE

# CAUTION REQUIRED TO CORRECTLY INSTALL THE TENSIONER ASSEMBLY AND AVOID PREMATURE FAILURE

**BULLETIN:** TSB017\_AU

- TCKH1601

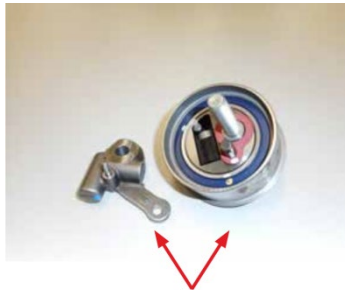
- The hydraulic actuator that sits on the tensioner pulley is not fixed and can easily be dislodged from its correct, ready to be installed, packaged state. This can occur from dropping or fumbling the unit during installation. **Keeping the rubber sleeve over the bolt threads until the very moment that the tensioner is to be installed** can help in preventing the hydraulic mechanism from separating from the tensioner pulley.
- **DO NOT remove the pin before installation.** Removing the pin before it's required will cause the hydraulic actuator to separate or partially separate from the pulley. This will cause the piston of the actuator to either completely exit the hydraulic chamber or fully extend to the end of its stroke suddenly.

- **Do not use** if hydraulic actuator has become separated from the tensioner pulley. There is an internal spring that will also need to be repositioned which can lead to premature failure if not done precisely.

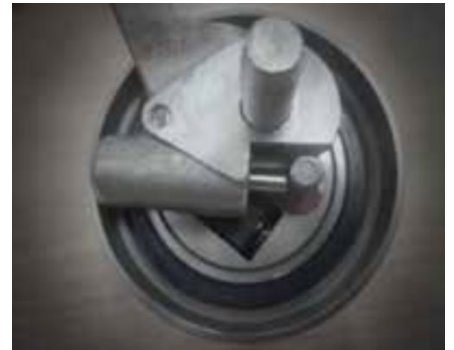
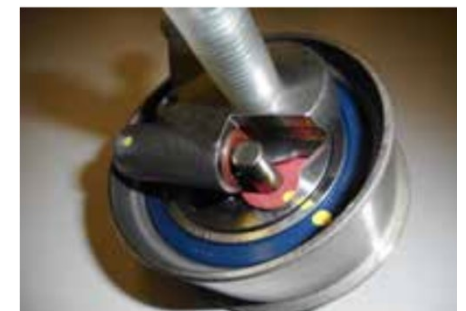
This is the correct state of the tensioner before installation.  
**DO NOT** install if the tensioner assembly does not resemble the image above.

- If the piston does exit the chamber completely **do not use**.
- If the piston of the hydraulic actuator projects suddenly without actually completely exiting the chamber, air flows into the chamber and causes sponge effect. You can check for sponge state by carefully forcing the piston to retract against a solid, flat structure (such as a metal pillar or concrete wall). You should not be able to move the piston at all, if there is even slight movement then sponge state has occurred. If this occurs, bleed the air from the pressure chamber using the bleed-out procedure described below.

- Install the tensioner to the engine.
  - Rotate the tensioner with a force of 39NM or less in an anticlockwise direction using an Allen wrench.
  - Then turn it back slowly.
  - Repeat this procedure several times.
  - Verify that the piston has resistance when it is in the most projected position. If there is no resistance, repeat the above procedure.
- 
- **Do not remove** set pin before installation of the belt and idler. Also ensure the tensioner bolts are tightened to specifications before releasing the pin. Refer to the OEM recommended installation procedure.
  - **T43009 Tensioner.** This tensioner unit is available separately from Gates.
  - If the piston has expelled before installation, it is likely that a bleed-out of air from the pressure chamber is required.
