## TECH NOTE

## INSTALLATION INSTRUCTIONS FOR BELT OAP7144

BULLETIN: TSB024\_AU

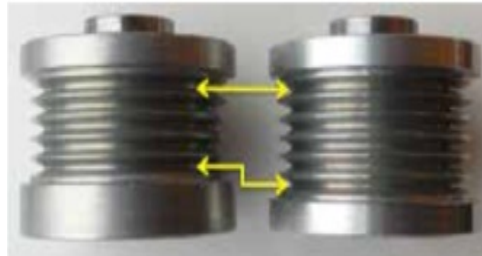
Fig. 1

On certain Opel/Vauxhall/ Holden engines (codes: A14NEL, A14NET, A14XEL, A14XER) the belts may have 5 or 6 ribs while the pulleys may have 5 or 6 grooves, depending on the manufacturing date of the car. Gates recommends replacement of a 5 groove OAP (Fig.1 left side) with the 6-grooved OAP7144 (Fig. 1 right side).

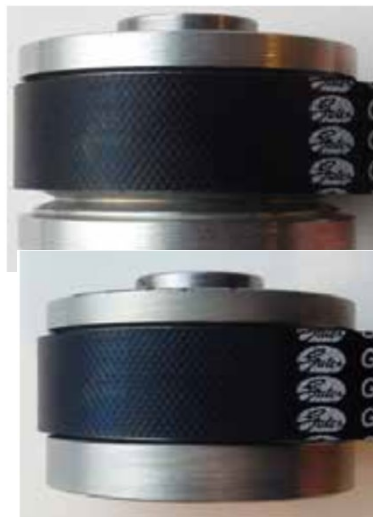
Fig. 3

If the belt is not placed correctly on the OAP like this, severe misalignment occurs, which may cause premature failure. Fig.3 shows an OAP with 5 grooves that must be replaced by the 6-grooved OAP7144.
