TECH TIP

COOLING SYSTEM

BULLETIN TT005-15

Water Pump Failure Signs

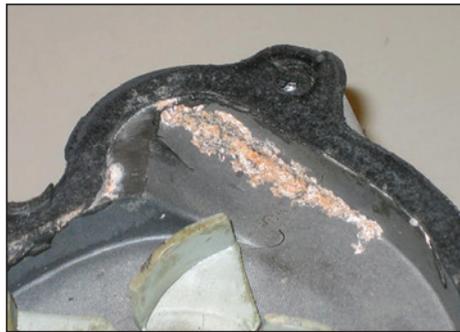
DEPOSITS/CALCIUM BUILDUP

If during the course of an inspection the water pump is found to look like any of the below, Gates recommends properly flushing the system, filling the system with a new mixture of the correct coolant, and possibly replacing the water pump depending on the issues found.

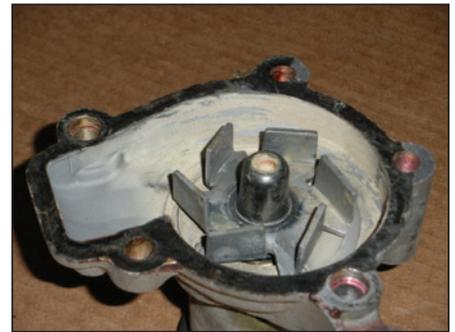
DEPOSITS/CALCIUM BUILDUP

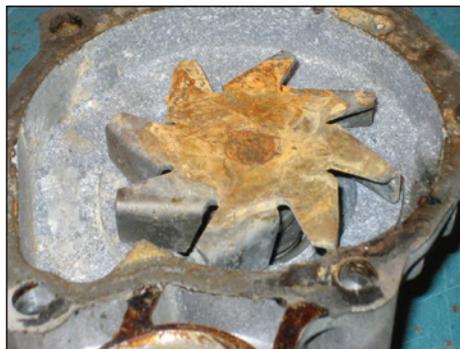
RUST/CORROSION

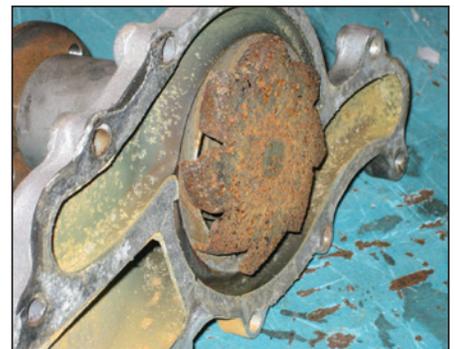
RUST/CORROSION

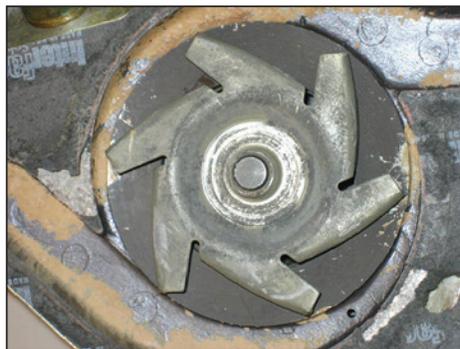
DEPOSIT BUILDUP

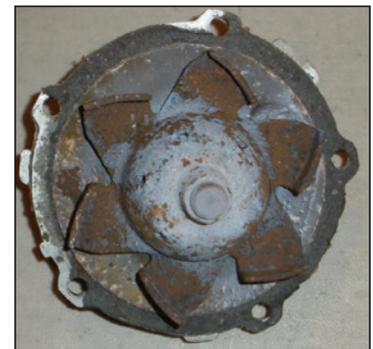
RUST/CORROSION

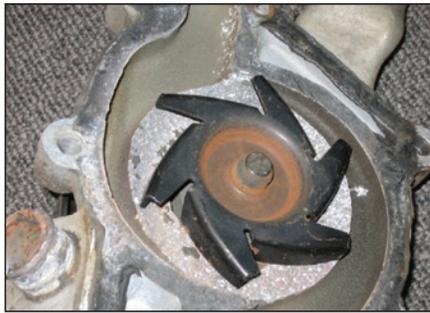
CAVITATION / CORROSION

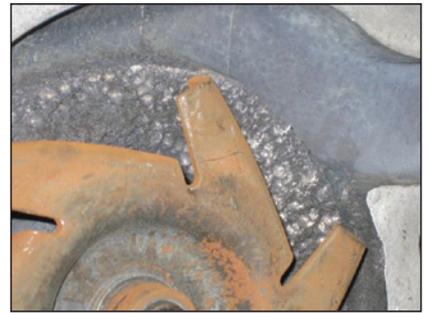
CAVITATION / CORROSION

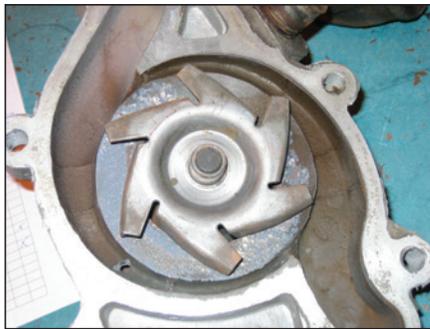
CAVITATION / CORROSION

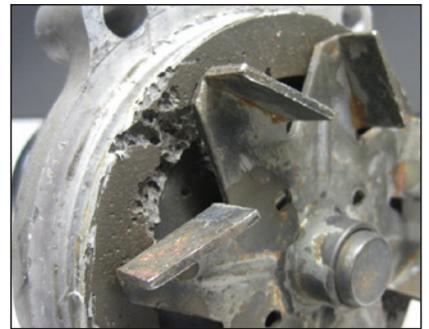
CAVITATION / CORROSION

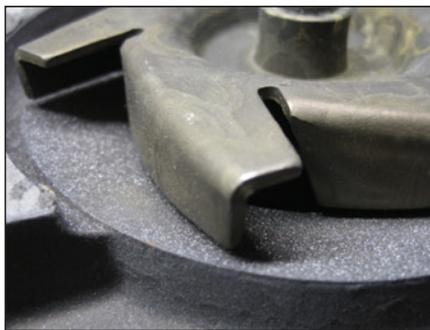
CHEMICAL ETCHING

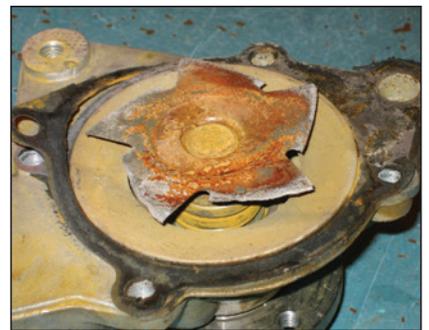
CORROSION
